EPA AUDIT REPORT – CROWN FOREST NORTH BROOMAN STATE FOREST, COMPARTMENT 42

Auditee:	Forestry Corporation of NSW				
Audit scope:	North Brooman State Forest, compartment 42 (see Map 1, below). The field audit took 1 day to complete.				
Region:	Southern Region				
Date/Audit timing:	12 July 2017				
Justification of audit:	Post-harvest audit focussing on EPA compliance priority areas				
Audit objectives:	 Determine compliance with Southern Region IFOA conditions 				
	Determine compliance with relevant planning conditions that relate to threatened species surveys				
	 Communicate compliance and non-compliances to FCNSW.

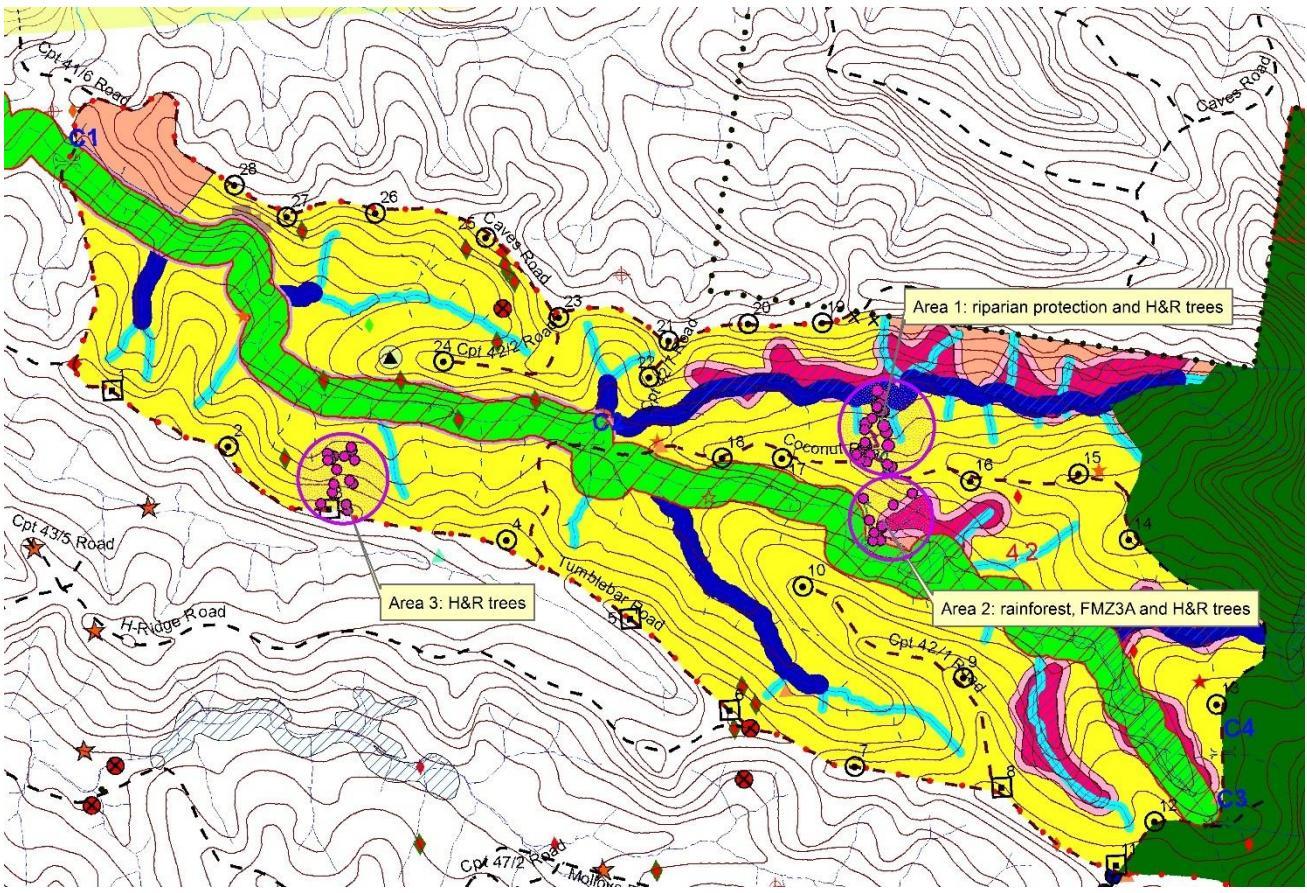
Map 1: Areas inspected during the EPA audit on 12 July 2017, compartment 42, North Brooman State Forest. The pink circles show waypoints recorded for the purposes of assessing boundaries and marking the locations of hollow-bearing and recruitment trees.

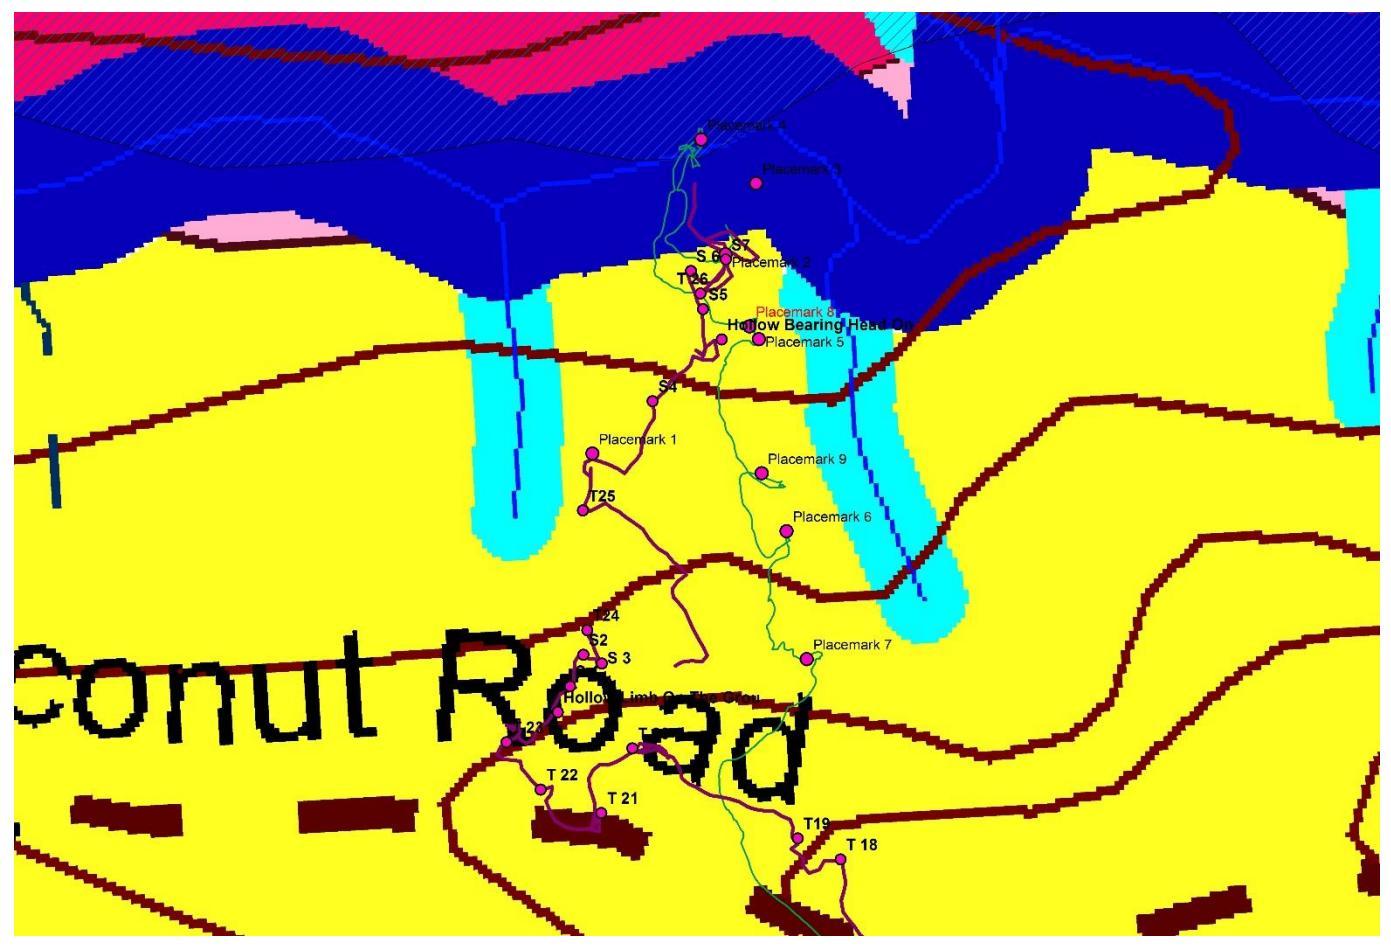
Map 2 (above): Audit area 1, located of Coconut Road in compartment 42, North Brooman State Forest. The descriptions for each of the waypoints labelled "T2, T3" etc, are provided in Table 1 and Table 2 attached to this report.

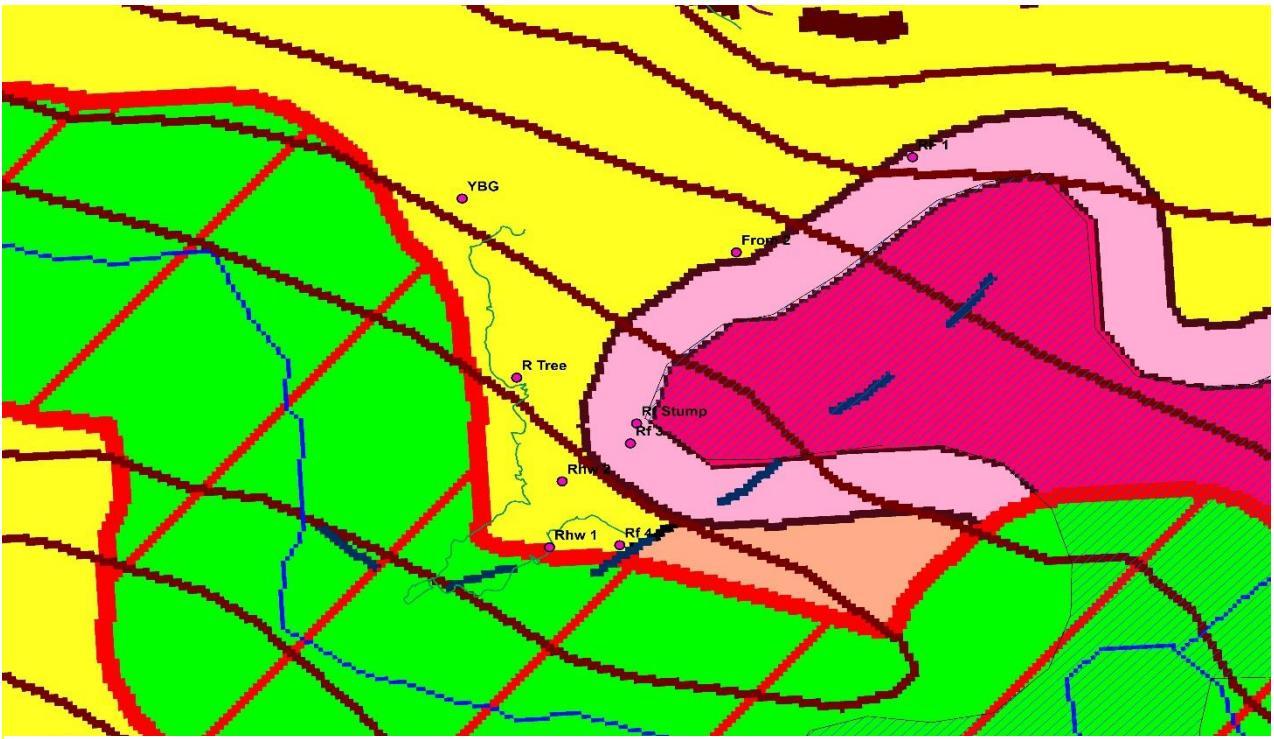
Map 3 (above): Audit area 2, located south of Coconut Road in compartment 42, North Brooman State Forest. The pink area shown is a rainforest exclusion and rainforest buffer (light pink), while the green is an FMZ3A overlaid by an owl exclusion zone (red cross hatching) and a ridge and headwater habitat. The details for each of the marked waypoints ("YBG, R Tree" etc) are provided in a table attached to this report.

During the field audit, the EPA assessed a ridge and headwater boundary south of Coconut Road, between log dumps 17 and 18 (**Map 3** at the start of this report). The harvest plan operational map produced by FCNSW shows a different boundary for the ridge and headwater than the official IFOA layer used by the EPA. However, to date the EPA has received no notification regarding such an amendment, and no justification for the amendment, contrary to condition 5.8(g) of the Southern Region TSL.

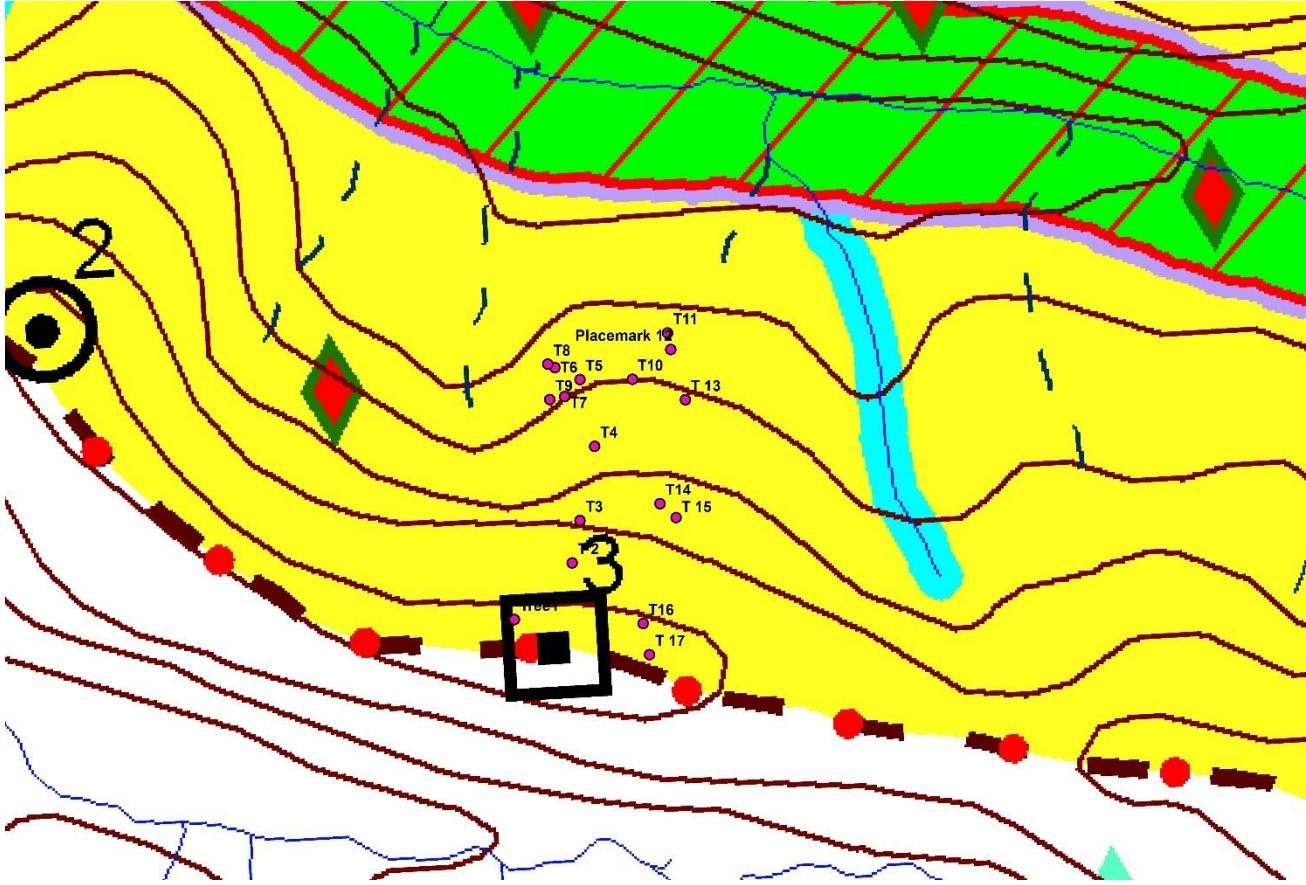
Map 4 (above): Audit area 3, north of log dump 3 on Tumblebar Road. The details of the waypoints (T2, T3, etc) are provided in a table attached to this report.

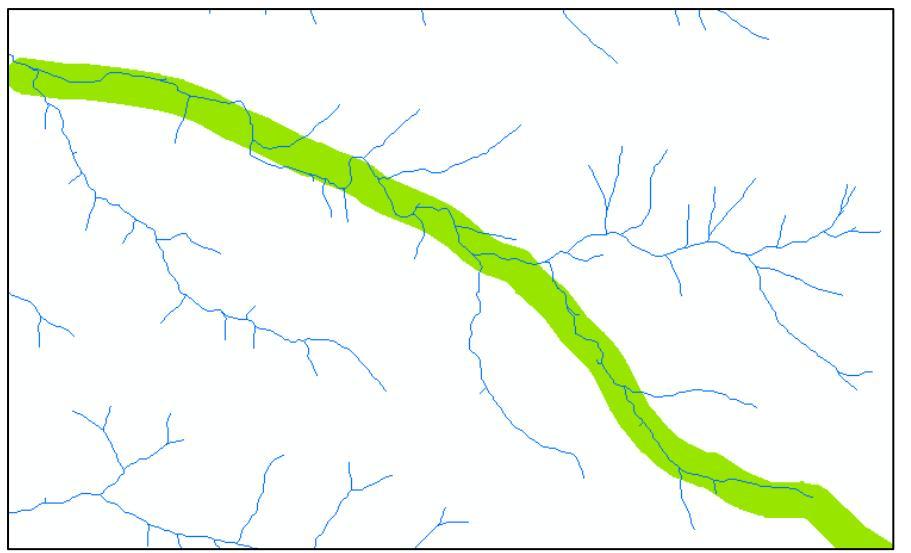
Condition / Audit finding reference / page No.	EPA draft finding / risk category	Location – description GPS	FCNSW evidence submission	EPA final finding / risk category	EPA response to FCNSW submission
TSL 5.8(g)	Amendment to the location of ridge and headwater habitat / ORANGE	P.13 of the report	A major benefit of the acquisition of LiDAR is that FCNSW are now able to accurately map the real-life location of drainage features. This has improved our ability to accurately apply the appropriate buffers/exclusions to drainage lines. Previous LIC drainage layers have been found inaccurate across much of the FCNSW estate, so the LiDAR derived drainage is now used when creating the Harvest Plan Operational Map (HPOM). A requirement of Ridge & Headwater Habitat exclusion zone network design is that exclusions follow 1 st or 2 nd order streams. The development of LiDAR derived drainage has also better enabled FCNSW to protect Ridge & Headwater Habitat. During harvest planning the location of the Ridge & Headwater Habitat exclusion is reviewed and amended based on the location of LiDAR derived drainage. This is done on a compartment by compartment basis as they come up for harvest. Prior to the acquisition of LiDAR drainage, operational outcomes would have been similar (although far less accurate) because the boundary would have been marked as found in the field rather than as mapped. There is no doubt that by amending the Ridge & Headwater Habitat exclusion zone for the HPOM we are better protecting for the intent of the TSL condition.	Not compliant/ ORANGE	The EPA upholds its findings. The audit identified that FCNSW failed to follow the correct procedure within the TSL. The TSL is clear under 5.8(g) which states that "Amendment to the location of Ridge and Headwater Habitat exclusion zones may not be made unless approved by EPA". The EPA did not approve these amendments. Consequently, the original exclusion zone is required to be protected as per the TSL requirements.

Figure 1 - Official Ridge & Headwater Habitat Exclusion layer and LiDAR derived drainage (compartment 42)

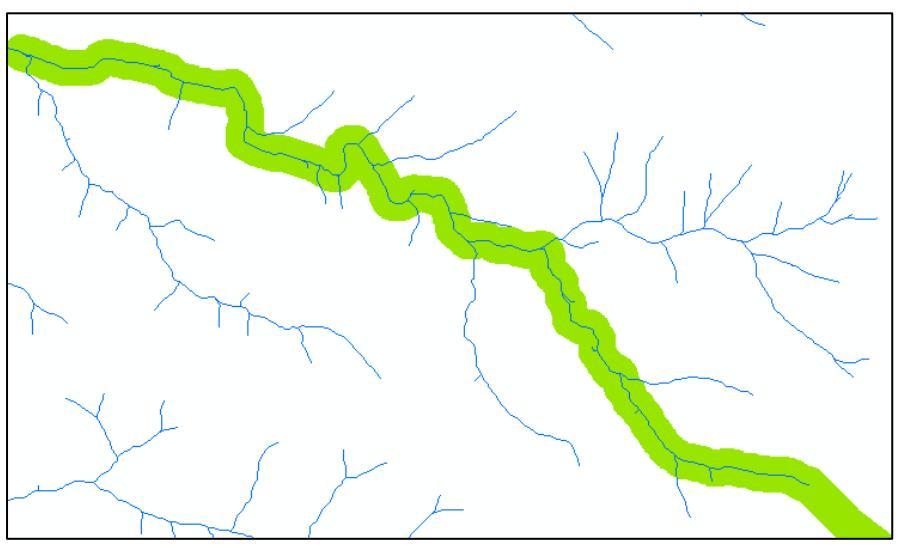
·,					
			Where FCNSW encounter a compartment that has had a Ridge & Headwater Habitat exclusion zone applied to a previous harvesting event (i.e. since the commencement of the current TSL) we take steps to ensure that the proposed exclusion zone matches the previously applied exclusion. This is done using LiDAR canopy height models and aerial photography during harvest planning and during on-ground pre-harvest mark-up survey assessments.		
			In compartment 42, the actual Ridge & Headwater Habitat exclusion area that was protected totalled 24.1 hectares. This compares to the 21.5 hectares that would have been protected had the exclusion been applied exactly as per the mapping on the official layer. Figure 1 below shows the official exclusion zone extent and the LiDAR derived (actual) drainage line. Figure 2 shows the exclusion zone extent applied by FCNSW against the LiDAR derived drainage. From these images we can clearly see that the modified Ridge & Headwater Habitat exclusion is better protecting the riparian zones. FCNSW argue that environmental outcomes are improved after applying an exclusion zone that has been modified based on LiDAR drainage. FCNSW request that this not be considered a non-compliance and that this be recognised in the final audit report and during

Figure 2 - Applied Ridge & Headwater Habitat Exclusion and LiDAR derived drainage (compartment 42)
