# AUDIT REPORT – BULLS GROUND STATE FOREST COMPARTMENT(S) 61, 62, 63, 64, and LORNE STATE FOREST COMPARTMENT (S) 75 and 76

Auditee:	FORESTRY CORPORATION OF NSW (FCNSW)
Audited State Forest & Cpts:	Bulls Ground State Forest, compartment(s) 61, 62, 63, 64, and Lorne State Forest Compartments 75 and 76 (see <u>Map 1</u> and 2, below). The field audit took 2 day(s) to complete.
Region:	Kendall Management Area
Date/Audit timing:	14-15 July 2016
Type of audit:	Compliance
Purpose of audit:	Report on the level of compliance with conditions and environmental performance in line with EPA compliance priorities.
Audit objectives:	<ol> <li>Assess compliance against audit criteria that reflect EPA compliance priorities.</li> <li>Assess and categorise risk of identified non-compliance or appropriate further observations.</li> <li>Request action plans against key audit findings so that auditee can use risk categorisation to inform timeliness and level of risk reduction control.</li> <li>Promote continuous improvement of the environmental performance of forestry operations.</li> </ol>

### ATTACHMENT 1: EPA FINAL AUDIT FINDINGS TABLE – BULLS GROUND STATE FOREST, COMPARTMENTS 61, 62, 63, 64, and LO

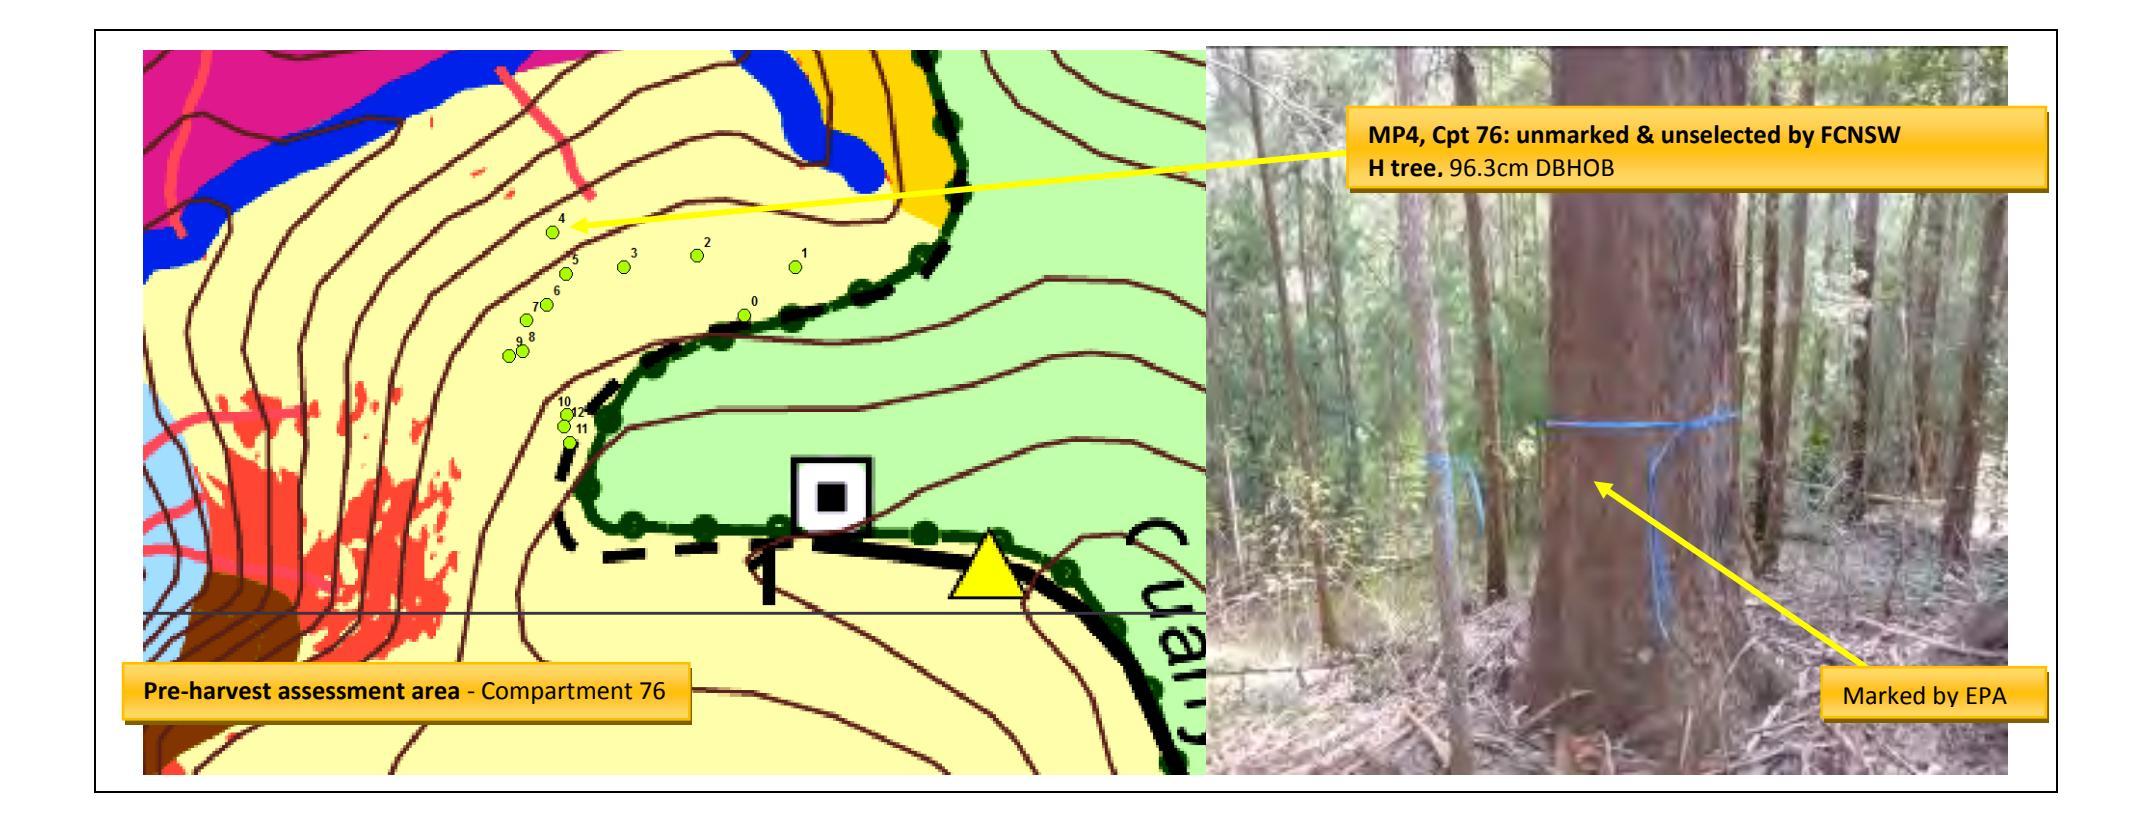
MP 4, Cpt 76: Unselected H tree in regrowth zone where the resource is scarce.

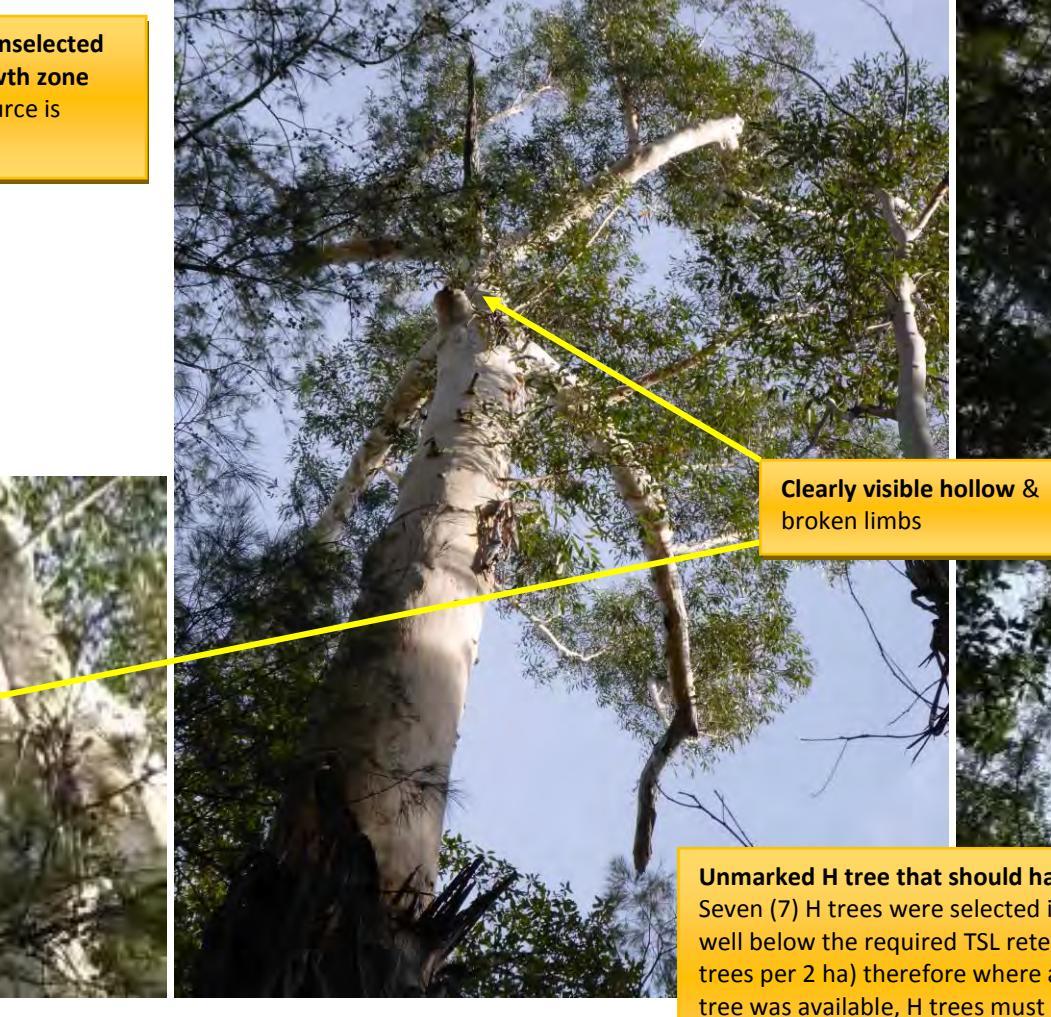
**Unmarked H tree that should have been selected.** Seven (7) H trees were selected in 3.67 ha. This is well below the required TSL retention rate (10 H trees per 2 ha) therefore where available, and this H tree was available, H trees must be selected and marked for retention up to the licence threshold with an accompanying R tree. Late mature dissipating crown

<b>CONDITION RELATED TO HOLLOW BEARING TREES (REGROWTH ZONE) – SELECTION</b>				
Condition No. and Detail	Compliant? Yes/No/Not determined/Not applicable	Number of non- compliance and (sample size)	Action required by licensee	
<ul> <li>5.6(d) Hollow Bearing Tree Selection – Regrowth Zone</li> <li>Within the Regrowth Zone the following requirements for retention of Hollow-bearing trees apply:</li> <li>ii. In selecting hollow-bearing trees for retention, priority must be given to any hollow-bearing trees which exhibit evidence of occupancy by hollow dependent fauna and trees which contain multiple hollows or hollows of various sizes.</li> <li>iii. Hollow-bearing trees must be selected with the objective of retaining trees having as many of the following characteristics as possible:</li> <li>belonging to a cohort of trees with the largest dbhob,</li> <li>good crown development,</li> <li>(Note: this does not restrict the selection of trees with broken limbs consistent with the hollow-bearing tree definition).</li> <li>minimal butt damage,</li> <li>represent the range of hollow-bearing species that occur in the area,</li> <li>located such that they result in retained trees being evenly scattered throughout the net logging area.</li> </ul>	No Code: Yellow	1/11 (3 H selected in 2 ha post-harvest assessed area; and 8 H in 3.67 ha pre- harvest assessed areas).	Action plan to be developed and implemented to ensure adequate H tree selection in accordance with condition.

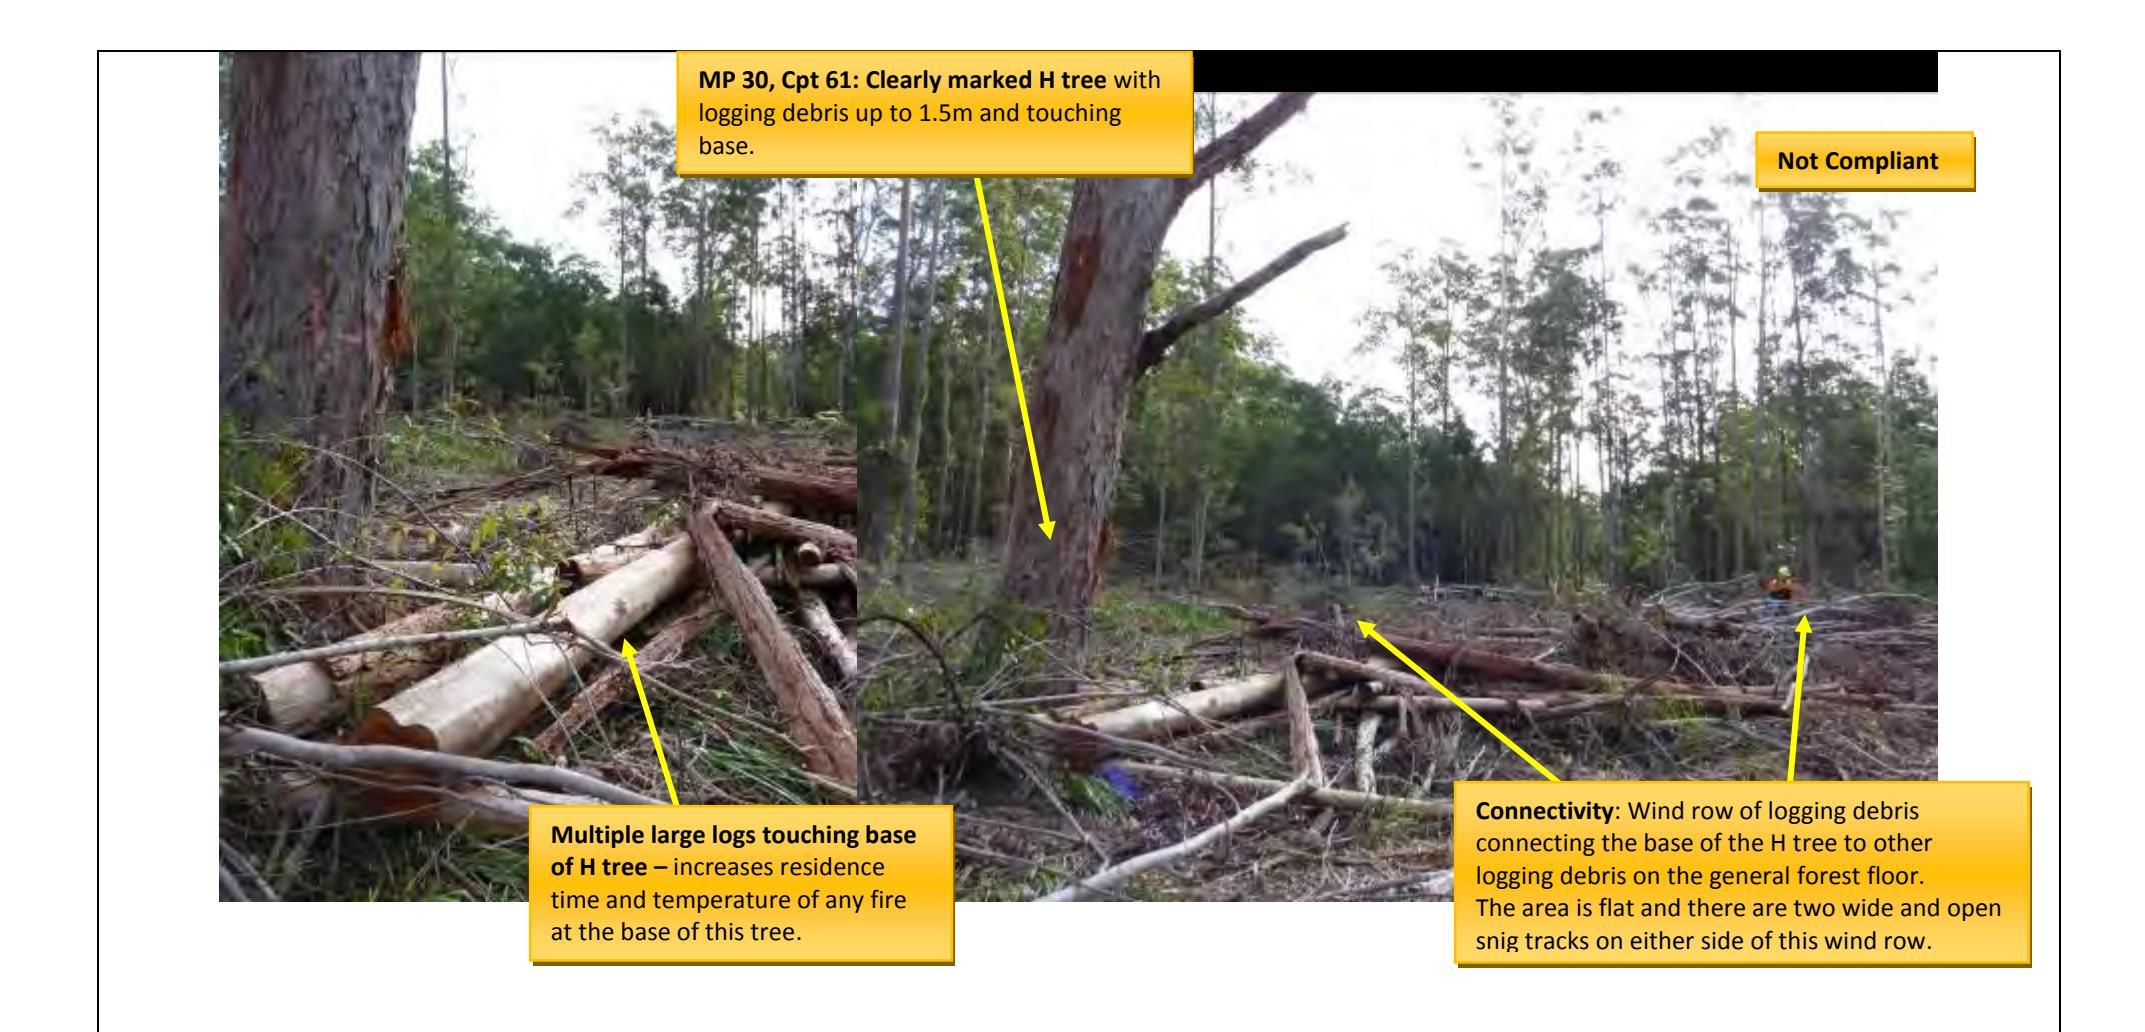
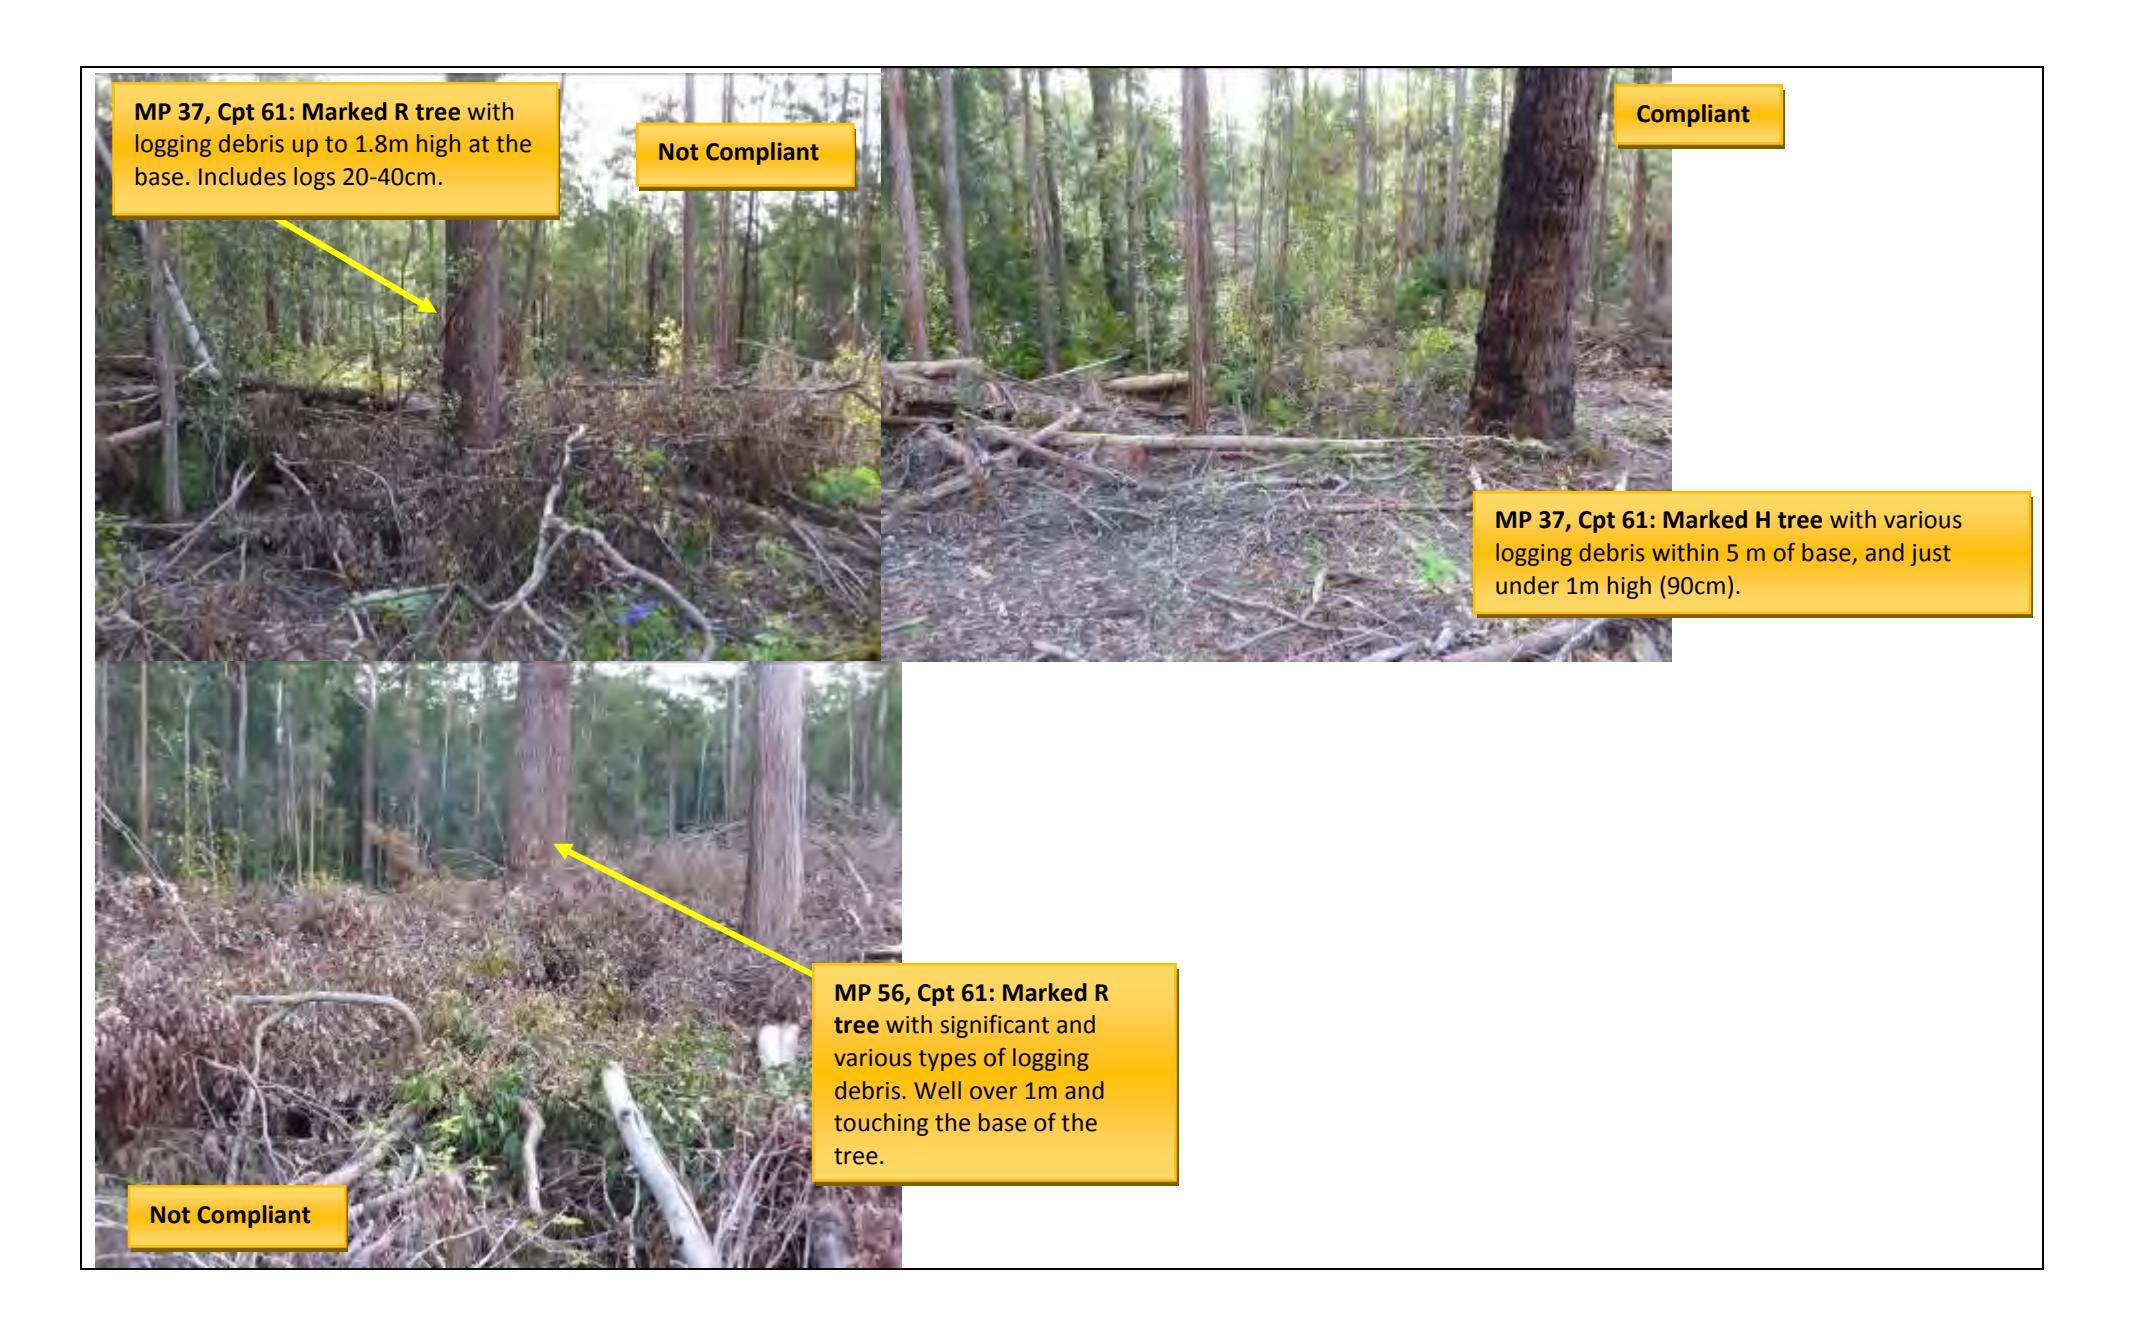
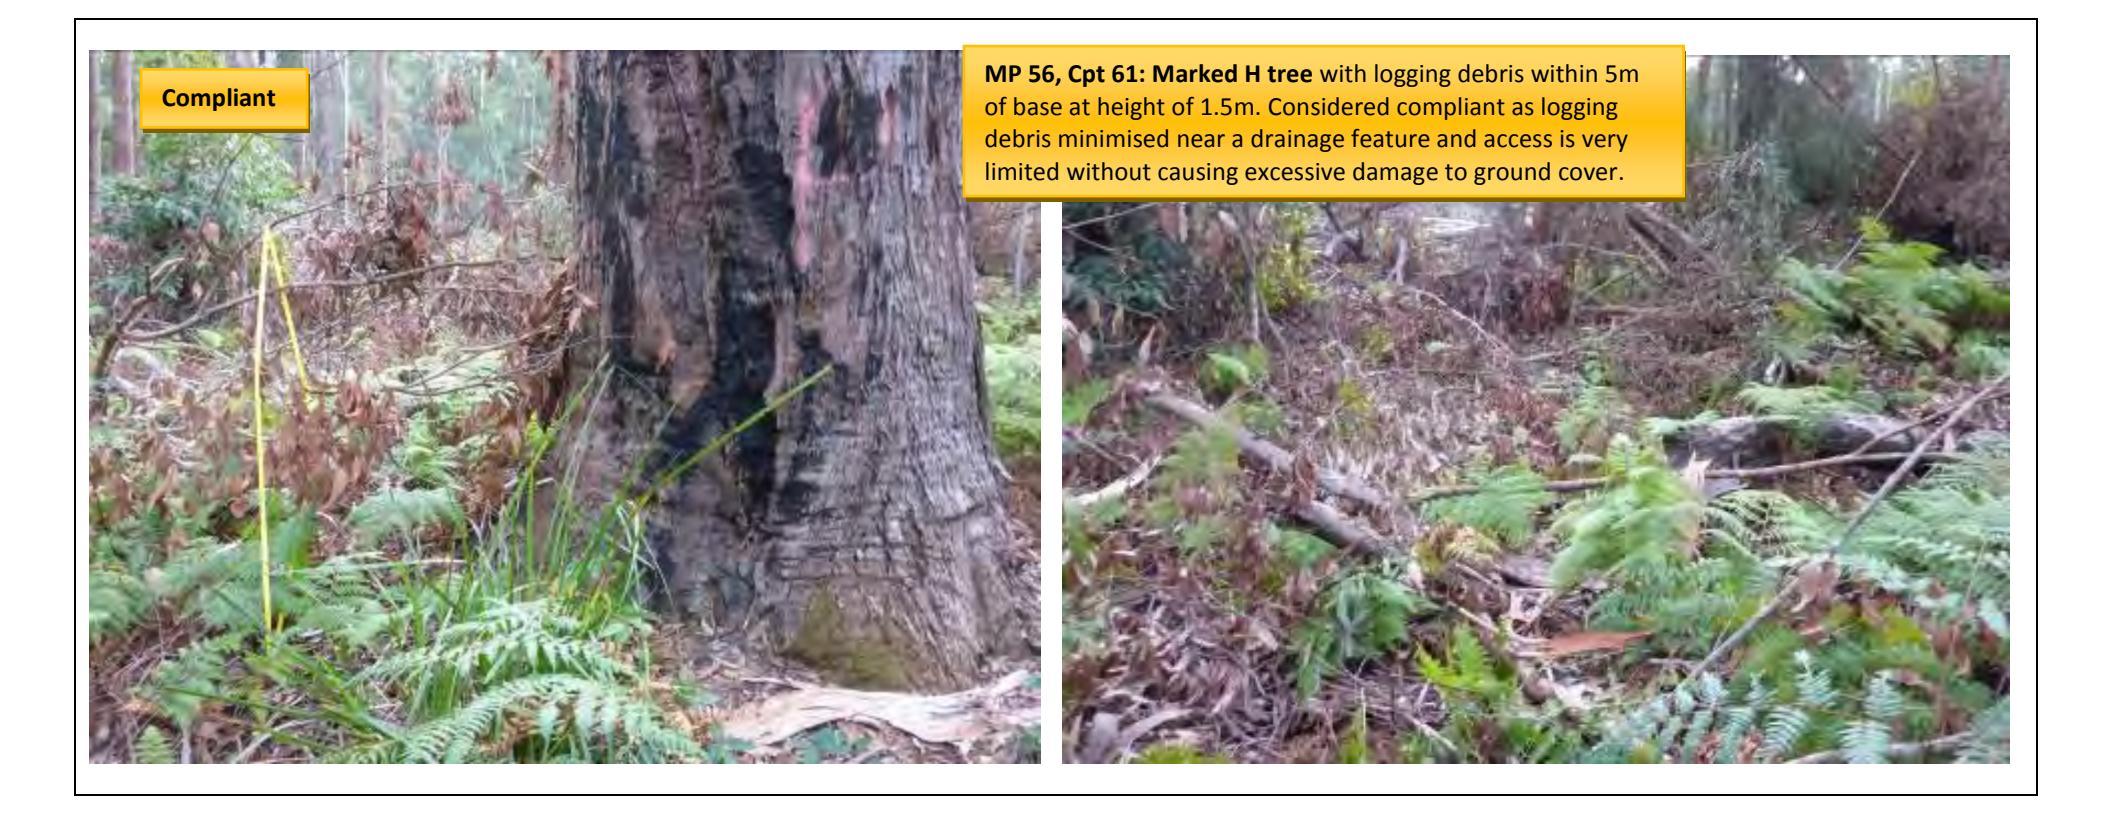
Comment and Ev	idence					
The EPA found that FCNSW was the trees that were retained and instances of non-compliance we This is a red code as the scarcit extent of logging debris around during harvesting; and in some	The EPA found that FCNSW was non-compliant with this condition. Assessments were completed only in post-harvested areas (Compartment 61), and considered the trees that were retained and counted for retention (marked and unmarked). Three (3) of the six (6) H and R trees required for retention were non-compliant. All nstances of non-compliance were associated with FCNSW marked and selected H and R trees. This is a red code as the scarcity of the resource is significant in this regrowth forest (that is, 6 H & R trees in 2ha). The rate of non-compliance is high and the extent of logging debris around each tree that was not compliant was also significant including logs, tree heads, and mid storey vegetation that was pushed over during harvesting; and in some instances, logging debris at the tree base was connected to other logging debris on the general forest floor.

35	Candidate R	Height of logging debris at base less than 1m.	Yes
37	Marked H	Logging debris within 5m of base, height of debris less than 1m (90cm).	Yes
37	Marked R	Excessive logging debris around base (within 5m), height of debris 1.8m (including logs 20-40cm) and extends to log piles outside 5m from base.	No
56	Marked H	Logging debris within 5m of base at height of 1.5m, however it is noted that this has been minimised to the greatest extent practicable.	Yes
56	Marked R	Logging debris height of 1.2m at base and 1.1m at 1m from base.	No

5.6(h)(i)&(ii) Protection of r	etained trees	No	3/6	Action plan to be develope	ed and		
In the course of conducting spec greatest extent practicable, be a hollow-bearing tree, recruitment cones beneath, eucalypt feed tre tree. Logging debris within a five flattened to a height of less than must be minimised to the greate Habitat and recruitment trees m operations.	In the course of conducting specified forestry activities, logging debris must not, to the greatest extent practicable, be allowed to accumulate within five metres of a retained hollow-bearing tree, recruitment tree, stag, <i>Allocasuarina</i> with more than 30 crushed cones beneath, eucalypt feed tree, or Yellow-bellied Glider or Squirrel Glider sap feed tree. Logging debris within a five metre radius of retained trees must be removed or flattened to a height of less than one metre. Disturbance to ground and understorey must be minimised to the greatest extent practicable within this five metre radius. Habitat and recruitment trees must not be used as bumper trees during harvesting operations.

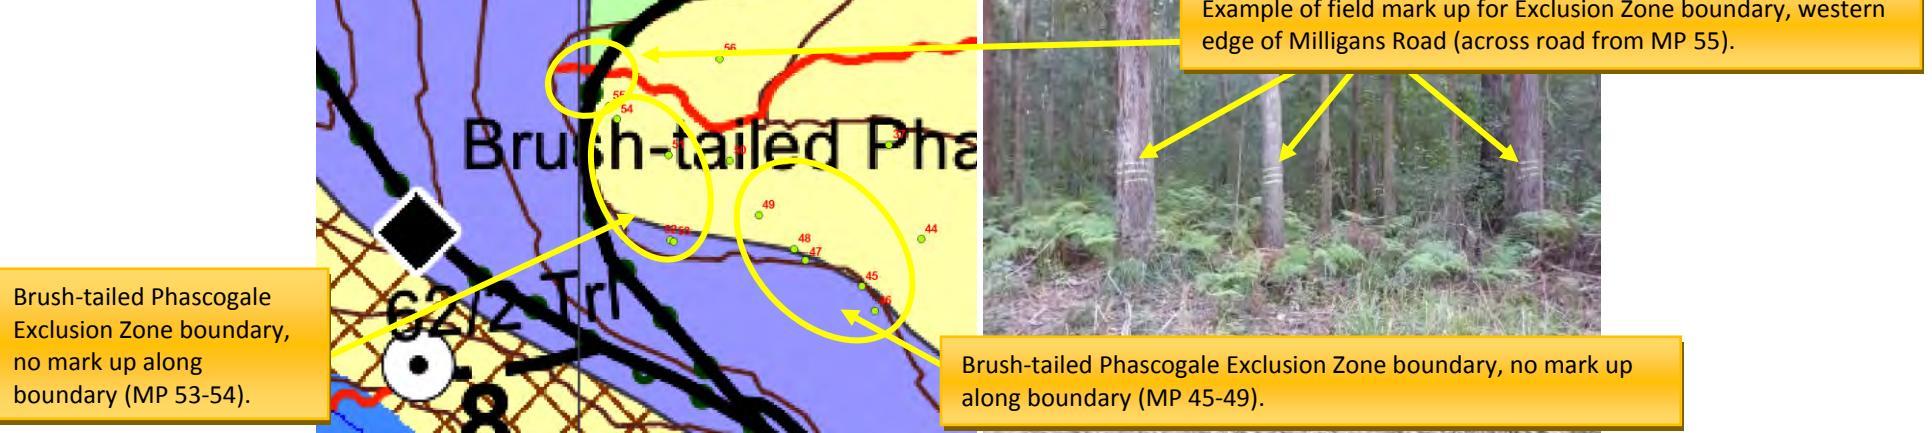
Comment and Evic	lence												
EPA officers assessed boundaries across three separate areas of the mapped Brush-taile 55). EPA found that FCNSW did not comply with conditions. There were no field marking to the post-harvest assessment area. The EPA Officers found an exclusion zone marking It is also noted that the prescription within the Harvest Operation Plan is for 'crew to identit	ed Phascogale Exclusion z s for the exclusion z on the western edg fy and implement m Examp	usion Zone boundary (l cone boundary in two o e of Milligans Road (co apped exclusion zone le of field mark up for Ex	MP 45-49; MP 53-54; and MP f the assessed areas adjacent prresponding with MP 55). using GPS/iPad'.

5.1 Operational requirements – Threatened species exclusion zone mark up No 2/3 Action plan to be developed													
f) All exclusion zone and buffer zone boundaries must be marked in the field, except where specified forestry activities will not come within 50 metres of such boundaries. The outer edge of lines shown on the map is considered to represent the boundary of the mapped feature when marking the feature in the field.	Code: Orange	(3 separate locations assessed)	and implemented to ensure exclusion zones are identified in accordance with this condition.

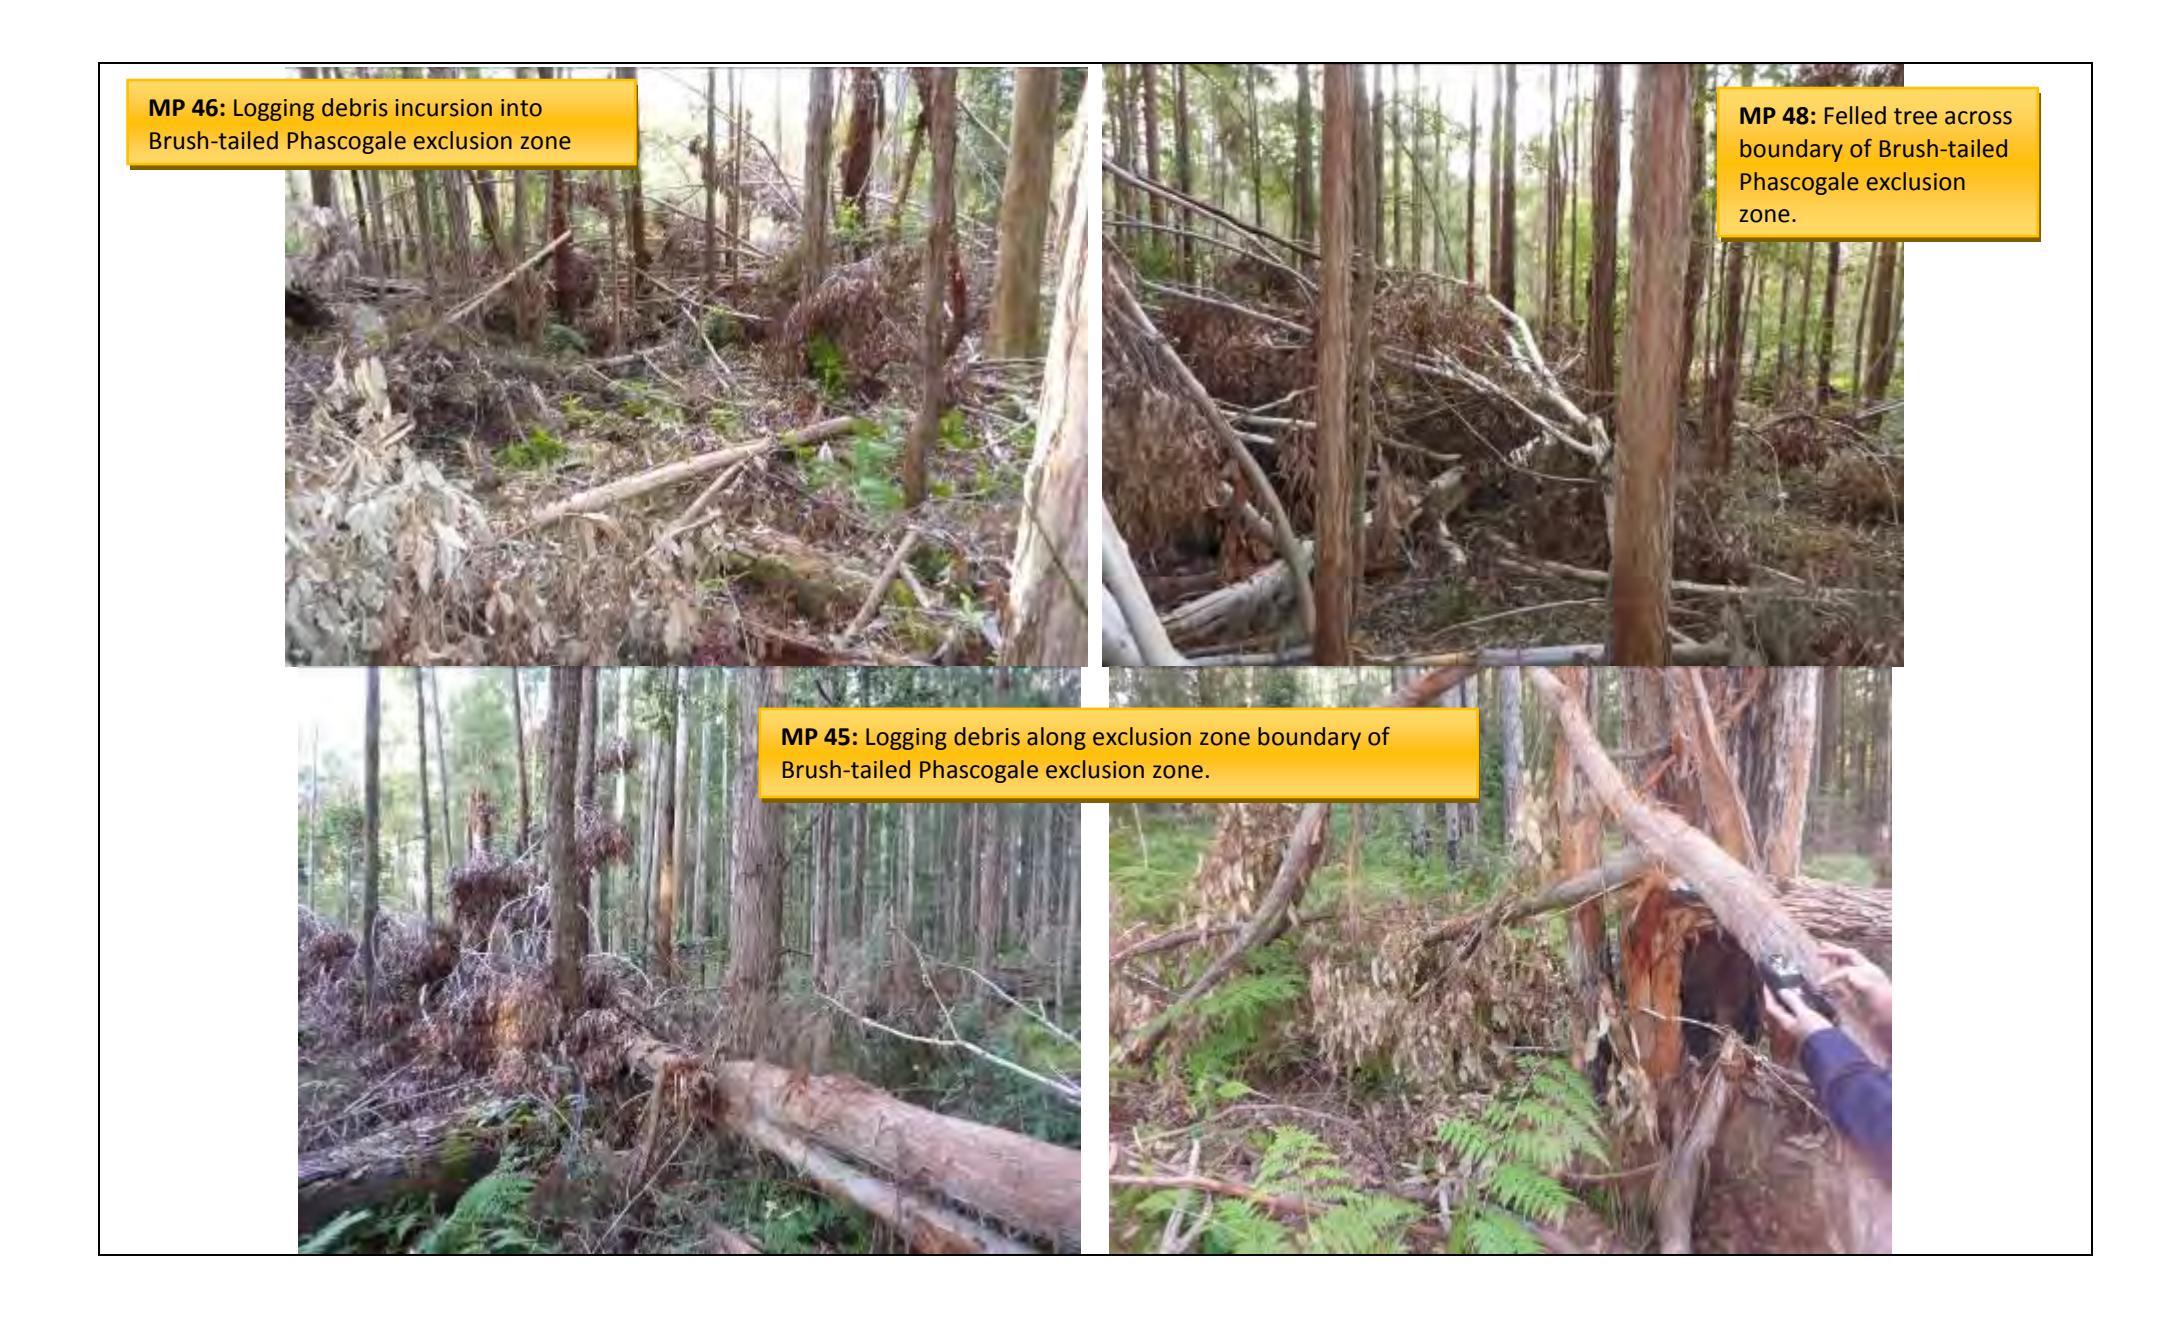
6.12.1 Brush-tailed Phascogale: Site Based Approach												
Comment and Evi	dence											
The EPA found that this condition was non-compliant in the assessed area, being the Brus	h-tailed Phascogale	e exclusion zone ide	entified within Compartment 61.									
EPA officers assessed boundaries across three separate areas (MP 45-49; MP 53-54; and were found along the boundary and fallen into the exclusion zone across one of the assess	MP 55) of the map sed areas (that is, M	ped exclusion zone IP 45-49).	e. Logging debris and felled trees

This non-compliance is considered yellow code as the incursions were relatively low in environmental harm, the sensitivity of the receiving receptor is moderate to high and the likelihood of environment harm occurring is relatively low.

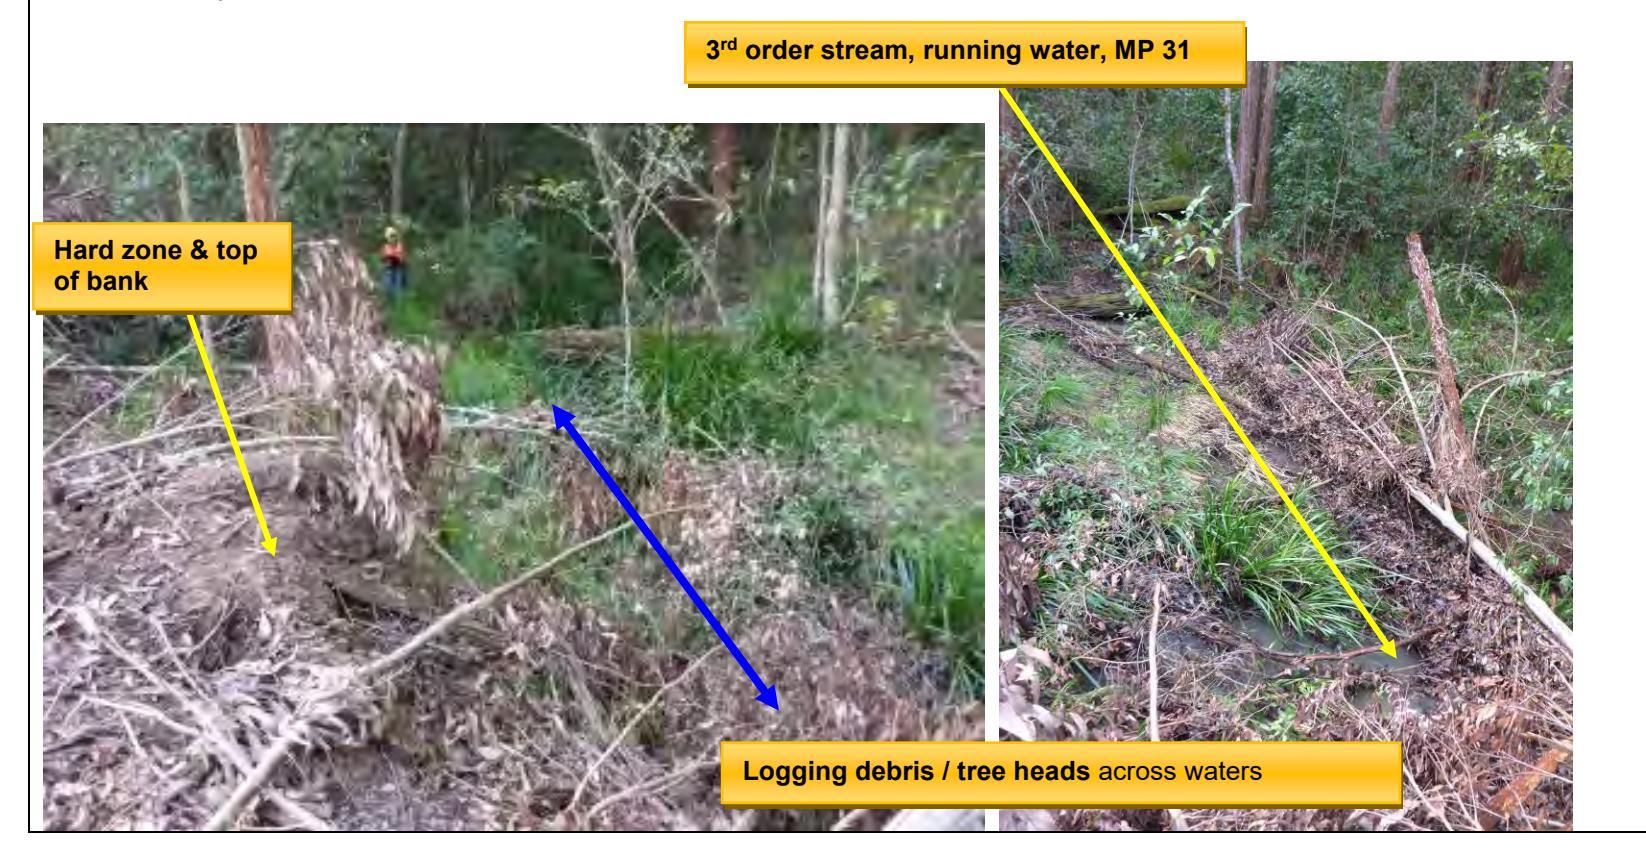
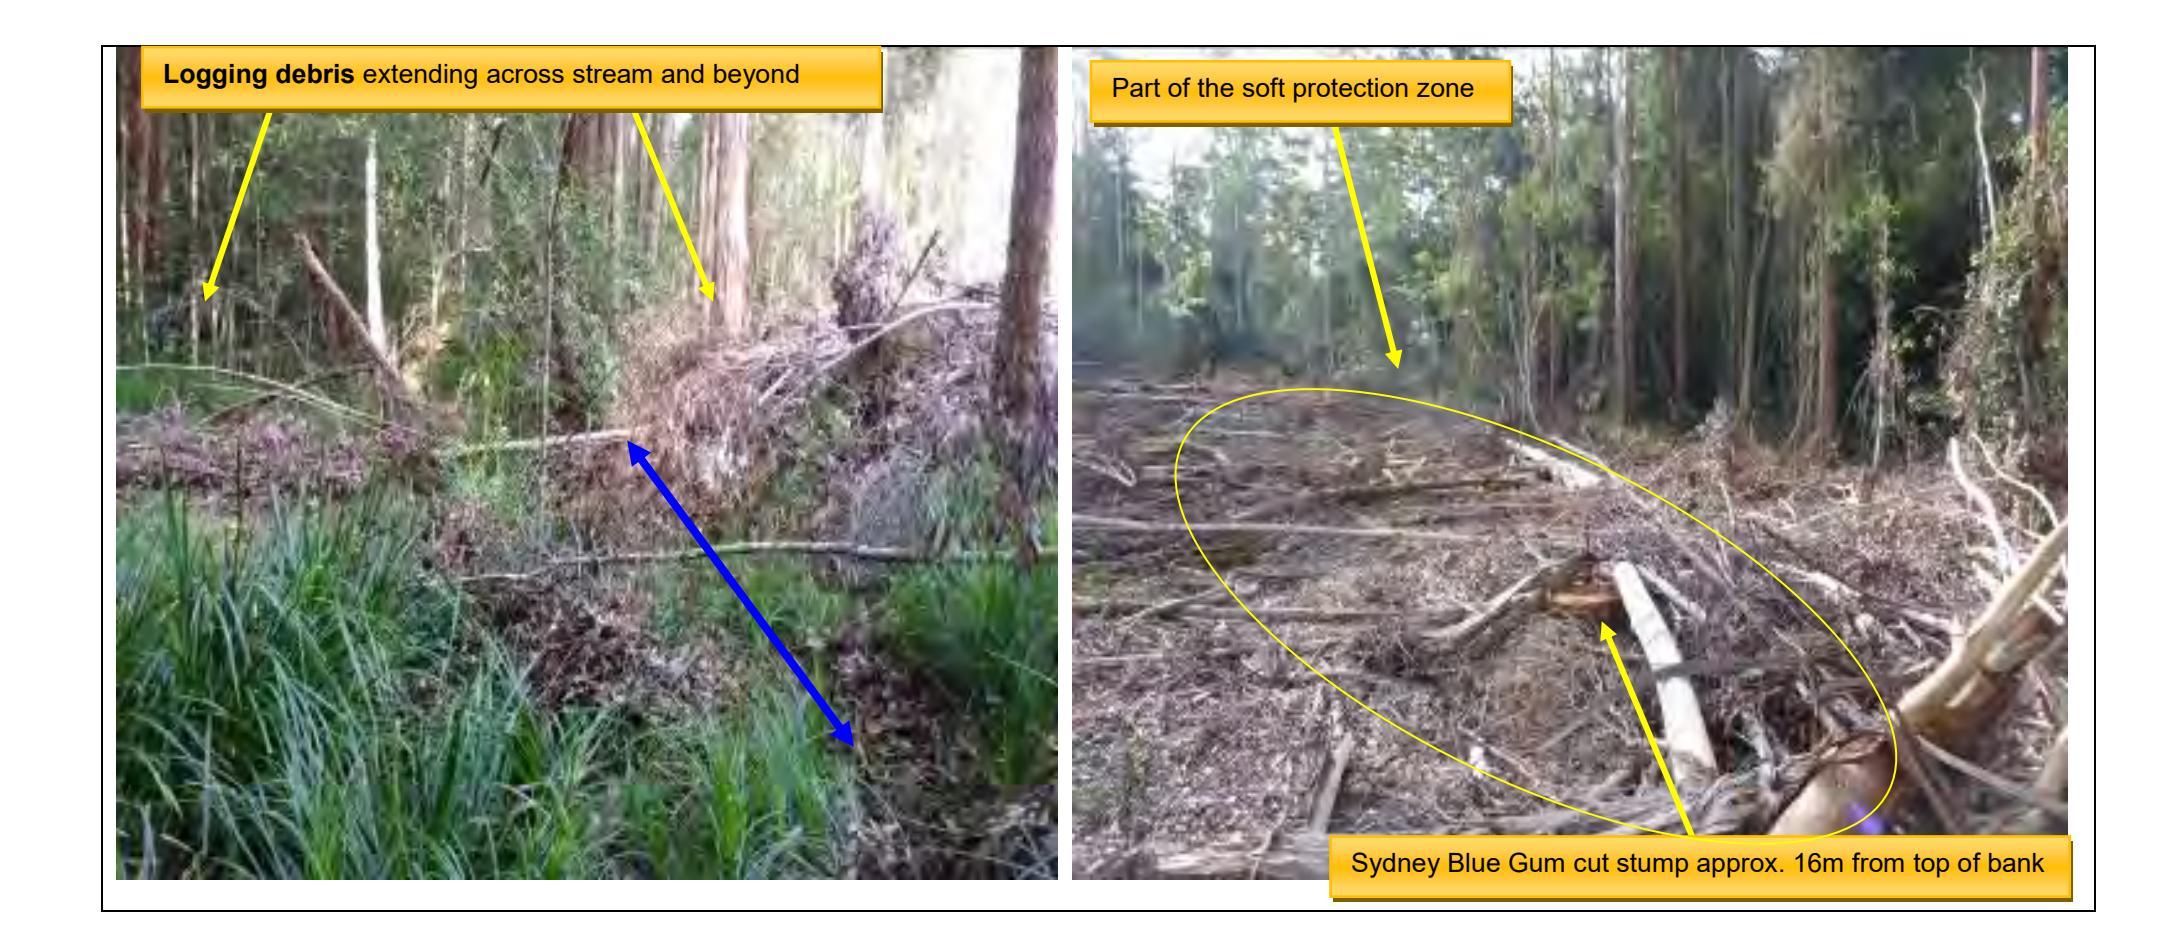
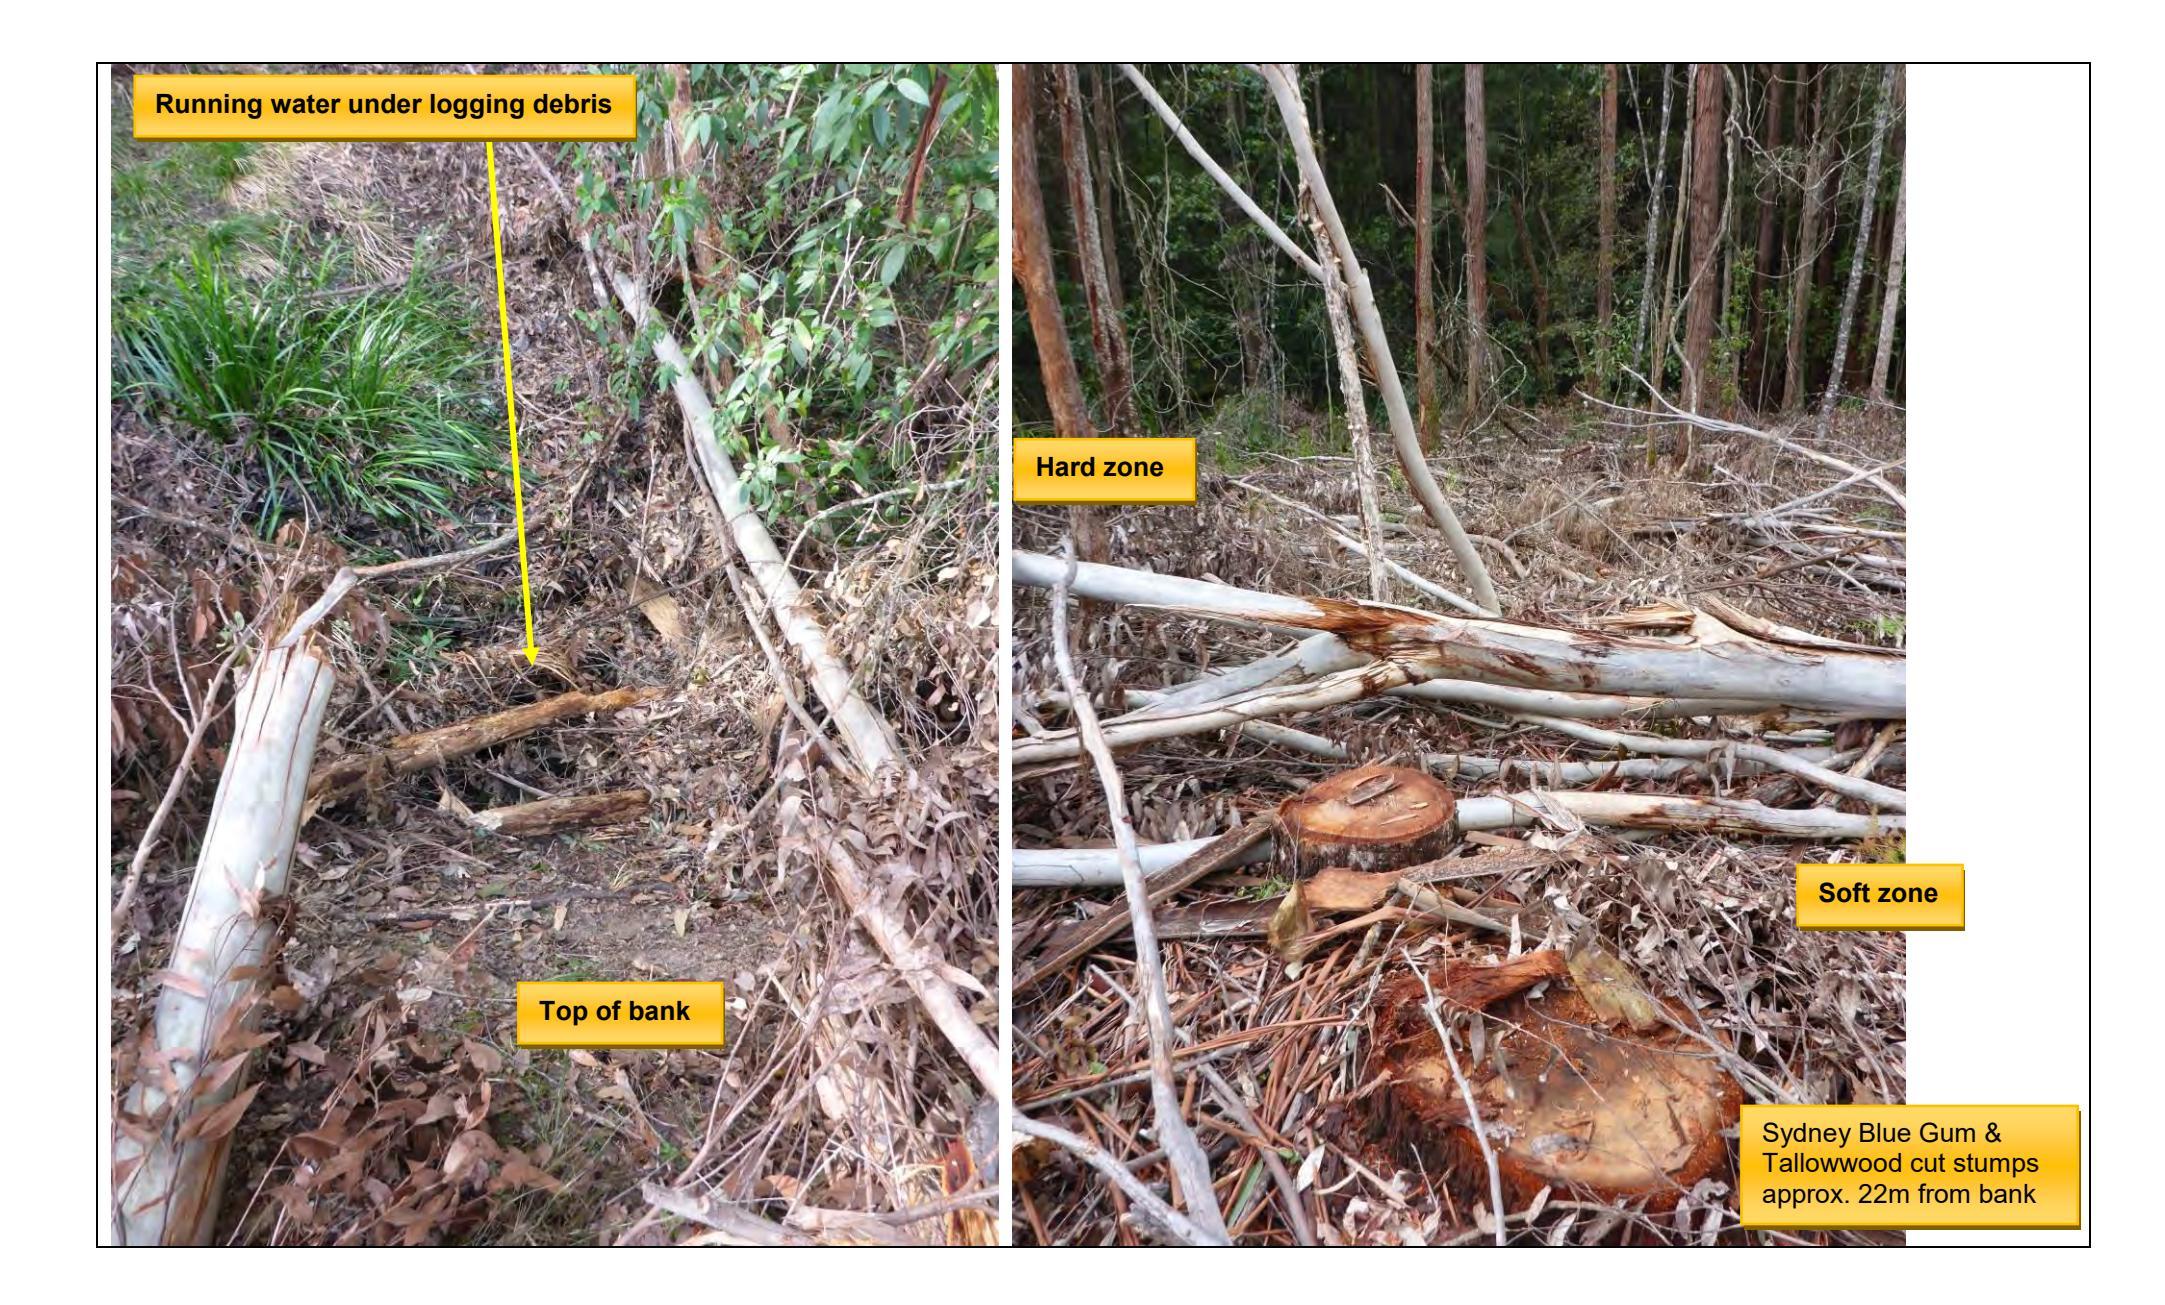
The EPA found that FCNSW did not comply with conditions for stream protection. The EPA assessed one area of the 3rd order stream protection zone within Compartment 61 (MP 31-34), and found incursions within the mapped 30m protection zone, including a tree felled across the stream, logging debris approximately 10m from the bank, and a stump approximately 15m from the bank.

The EPA found no field mark up of the stream protection zone. The FCNSW Harvest Plan Operational Map identifies the stream adjacent to the assessed area in Compartment 61 as a 3rd order stream, with protection area of 30m. It is noted that the prescription for Riparian Habitat Protection in the Harvest Plan is that 'the crew will locate and protect all 2nd order and above streams with GPS'.

5.7 Riparian Habit	at Protection – protect	tion zones		No	1/1	This matter is being investigated
5.7.1 Specified for	estry activities restric	ted within protection	zones (hard)			outside the audit process.
