# AUDIT REPORT – BULLS GROUND STATE FOREST COMPARTMENT(S) 61, 62, 63, 64, and LORNE STATE FOREST COMPARTMENT (S) 75 and 76

Auditee:	FORESTRY CORPORATION OF NSW (FCNSW)
Audited State Forest & Cpts:	Bulls Ground State Forest, compartment(s) 61, 62, 63, 64, and Lorne State Forest Compartments 75 and 76 (see <u>Map 1</u> and 2, below). The field audit took 2 day(s) to complete.
Region:	Kendall Management Area
Date/Audit timing:	14-15 July 2016
Type of audit:	Compliance
Purpose of audit:	Report on the level of compliance with conditions and environmental performance in line with EPA compliance priorities.
Audit objectives:	<ol> <li>Assess compliance against audit criteria that reflect EPA compliance priorities.</li> <li>Assess and categorise risk of identified non-compliance or appropriate further observations.</li> <li>Request action plans against key audit findings so that auditee can use risk categorisation to inform timeliness and level of risk reduction control.</li> <li>Promote continuous improvement of the environmental performance of forestry operations.</li> </ol>

### ATTACHMENT 1: EPA FINAL AUDIT FINDINGS TABLE – BULLS GROUND STATE FOREST, COMPARTMENTS 61, 62, 63, 64, and LO

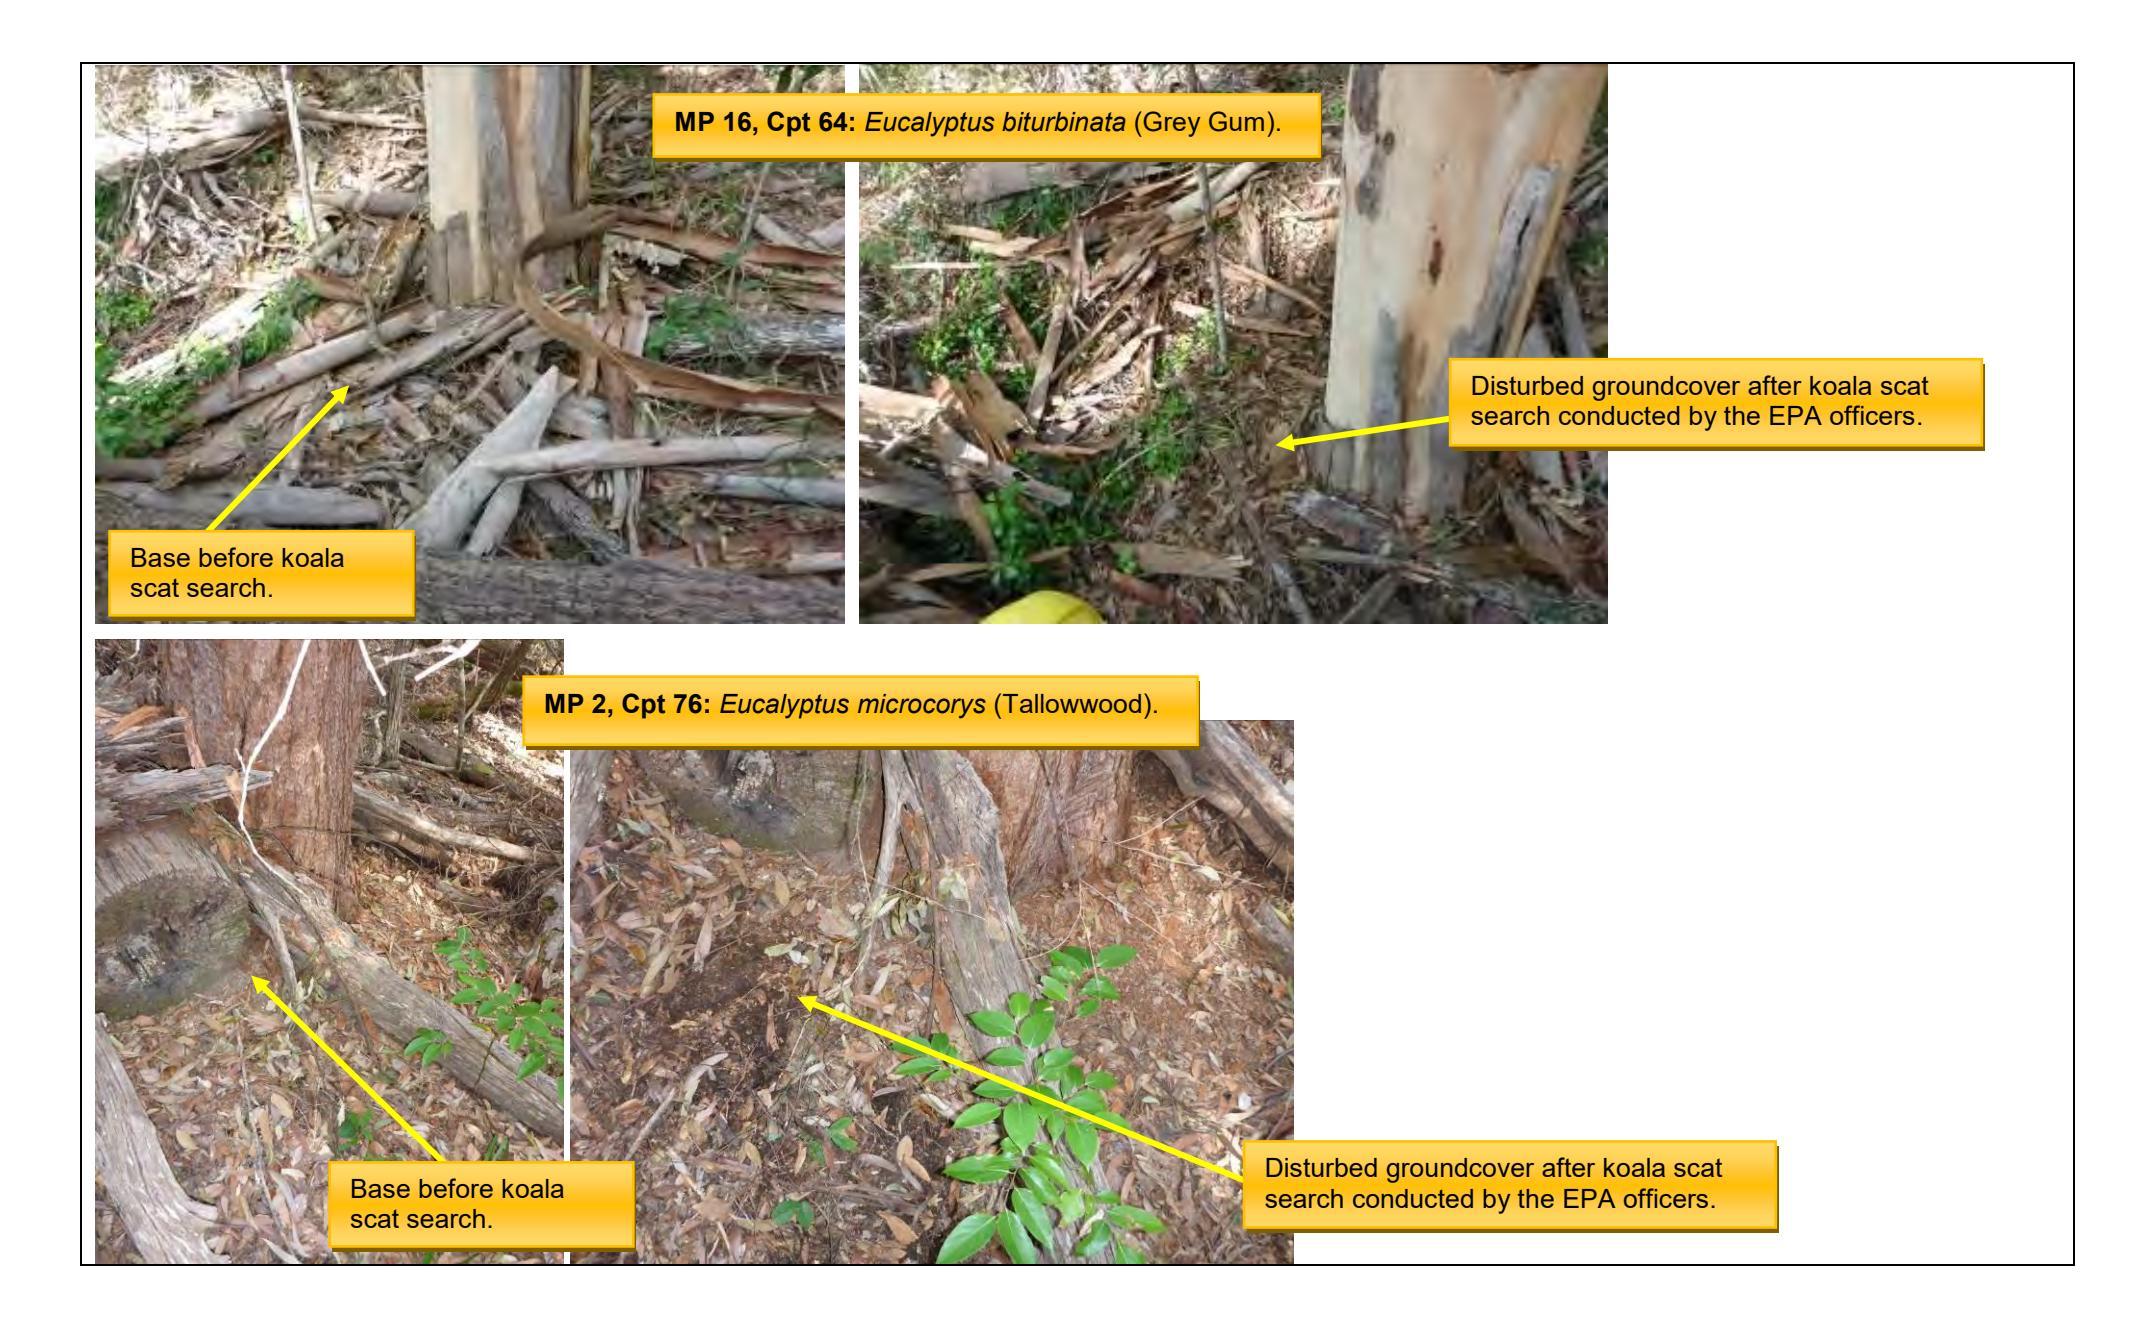
Comment and Evid	ence											
The EPA found that this condition was non-compliant in the pre-harvest assessed area. The EPA assessed two separate locations of pre-harvest area (that is, Compartments 64 and 76), searching primary koala browse trees, and found both areas did not show evidence of searching that had disturbed the ground cover. Accordingly, EPA considered at the time of the audit inspection that the ground around the primary browse trees was not thoroughly searched. There were marked H & R trees in the vicinity so FCNSW staff presence 300m ahead of operations was confirmed.												
<b>Further observation:</b> It appeared that compartment mark up at the Cpt 76 location was done quite some time ag	o and not recently.	The intent of perfor	ming the thorough koala searching

300m ahead operations is to capture contemporary koala use.

5.2.2 Koala Mark-up Searches	No Code: Orange	2/2	Action plan to be developed and implemented to ensure Koala									
at least 300 metres in advance of harvesting operations.	oute. Orange	locations assessed)	conducted in accordance with this condition.									
		pre-harvest areas only

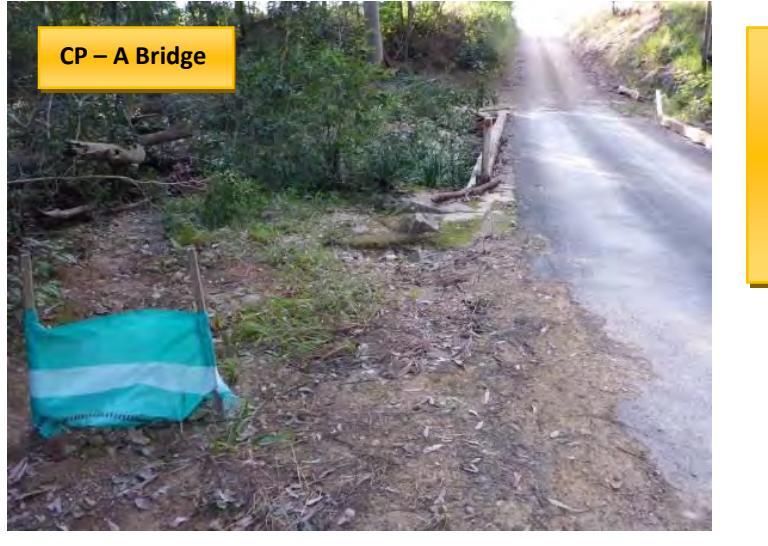
**Compartment 63 – non-compliant crossings**

Crossing drainage structures consist of table drains at 30 metres in both directions. Sediment traps are located at the ends of the table drains and terminate with geotextile sediment traps, which are not effective. There is soil gouging outside of the traps. The northwest sediment trap is not functioning at all. Sediment is moving from the road into the waterway despite the sediment traps. This crossing requires maintenance.
